ETHICON, INC.

SEVEN YEAR DATA FOR TEN YEAR PROLENE® STUDY: ERF 85-219

Interim report on the physical testing of PROLENE, PVDF, ETHILON & NOVAFIL after seven year subcutaneous implantation in the Beagle Dogs - TEN YEAR BSR STUDY, ST#E211-92, 85-219

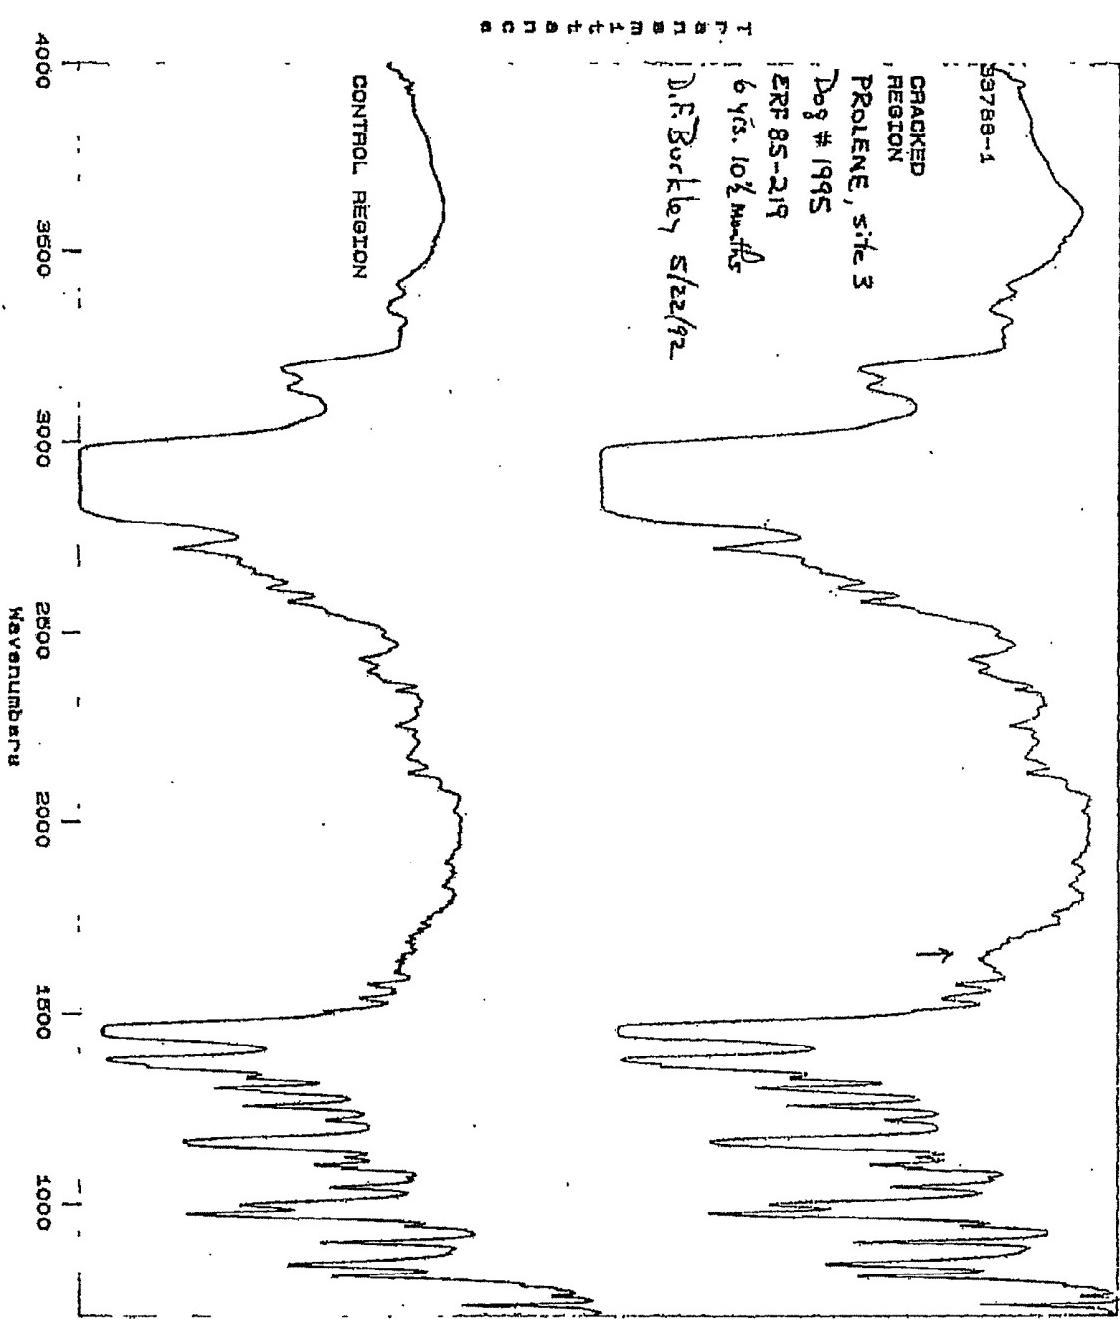
Figure A - Comparison IR Spectra of Cracked and Non-cracked Regions of PROLENE (SR33788)

IR microspectroscopy was used to examine cracked areas in ETHILON, Novafil and PROLENE® explants. IR spectra obtained for cracked PROLENE specimens (Figure A) showed possible evidence of slight oxidation (a broadened weak absorbance at about 1650 cm⁻¹). IR spectra obtained for cracked areas of ETHILON and Novafil did not differ from uncracked areas (Figures B and C), but expected IR absorbances for oxidation would be masked by the strong carbonyl absorbances normally observed for these sutures. Figures D and E show pictures of the areas examined by IR microspectroscopy for ETHILON and Novafil.
